FZR-298

August 2000

**Metallographic Post-Test
Investigations for the Scaled
Core-Meltdown-Experiments
FOREVER-1 and -2**

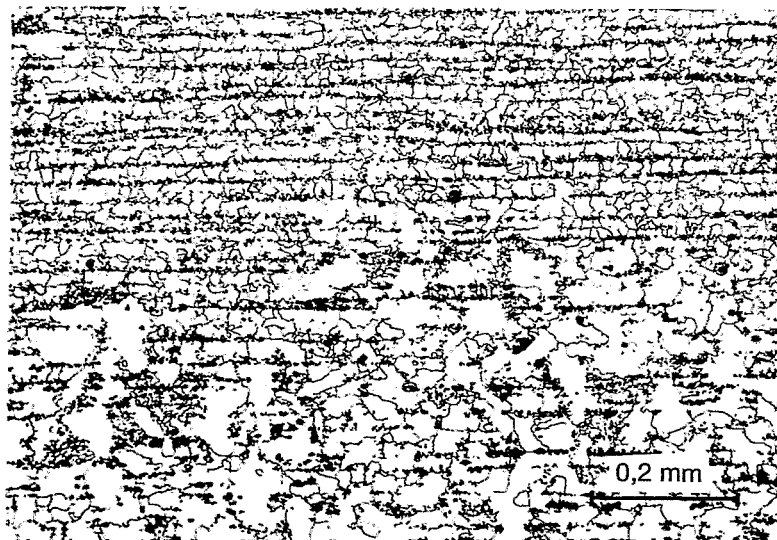
The microstructure after annealing is shown in Figs. 13-20 according to the different annealing temperatures and cooling rates. The microstructure before annealing corresponds to the microstructure of samples C1/1 (Fig. 4) and C1/2. As already mentioned the microstructure is heterogeneous over the wall thickness and consists of fine-grained ferrite and perlite at the inside, polygonal ferrite and banded perlite near the middle and a ferrite-banded perlite mixture with coarse-grained ferrite cluster at the outside. Annealing at 700 °C (Figs. 13, 14) or 800 °C (Figs. 15, 16) does not change the initial microstructure. Firstly annealing at 900 °C (Figs. 17,18) modifies the initial microstructure. This is particularly visible after air cooling. In this case a mixture of polygonal ferrite, perlite and bainite occurs. The banded arrangement disappears (Fig. 18). After furnace cooling the microstructure contains polygonal ferrite and perlite which is only partly banded (Fig. 17). A clear effect shows annealing at 1050 °C (Figs. 19, 20). After furnace cooling a very coarse-grained microstructure consisting of polygonal ferrite and mainly banded perlite is created whereas after air cooling the most characteristic feature is a coarse bainite.

A microstructural transformation also shows the 15 Mo 3 steel of the upper cylindrical part of vessel near the weld. The microstructure consists of coarse-grained polygonal ferrite, banded perlite and inclusions of coarse bainite. The grain size and the fraction of bainite increase with decreasing distance to the wall inside. This feature indicates a complete transformation of the initial microstructure to austenite during the experiment. The grain growth is produced by higher annealing temperatures. The annealing experiments with samples of 15 Mo 3 steel from the FOREVER-C1 experiment provide similar structures (Figs. 19, 20). For example the

microstructure after annealing at 1050°C is comparable with the inside microstructure. However, the characteristic of the bainite points to a relatively fast cooling rate.

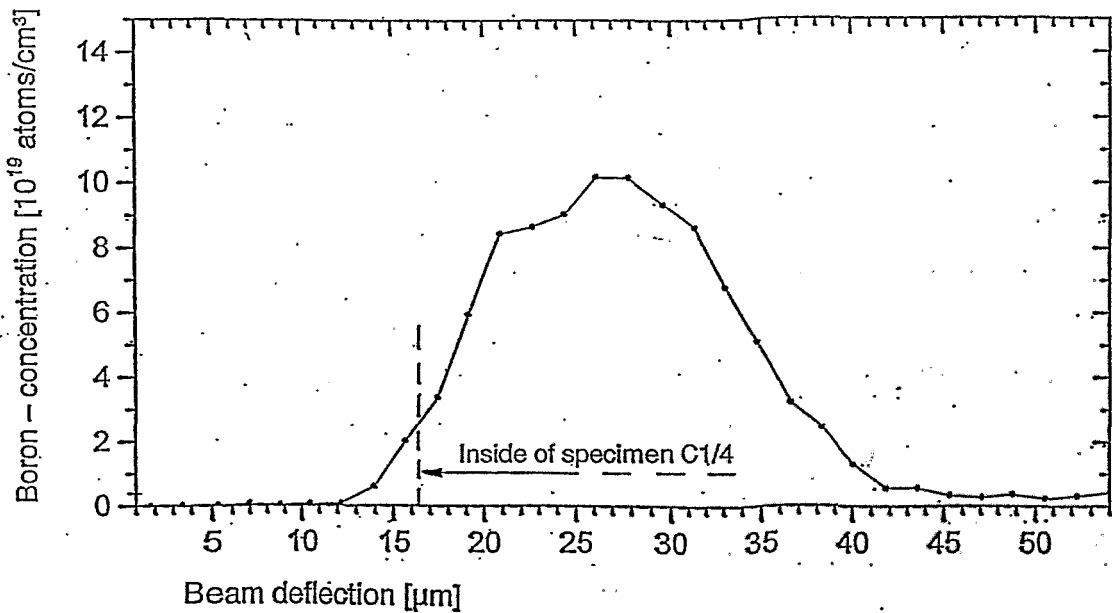
Fig. 21: Variation of the boron concentration with the distance, as determined by ion-microprobe technique

In the interior surface layer of sample C1/4, the diffusion of boron from the melt into the inside of the vessel was presumed. There the grains are arranged perpendicularly to the surface and a subsequent fine-grained decarburized layer is formed. The peripheral layer has a width of approx. 20 μm . In this layer an increase of the boron concentration by approx. 25 times compared to the boron concentration of the residual cross section was measured by the ion-microprobe method. Fig. 21 presents the course of the concentration of boron in dependence of the distance of the inner surface. From the result, a concentration of boron of 0,08 % in the diffusion layer is estimated. The width of this diffusion layer agrees very well with the light microscopic observation as shown in Fig. 22. At a further location of the same sample a diffusion zone of boron could not be clearly proved. The phenomenon was only observed at sample C1/4.

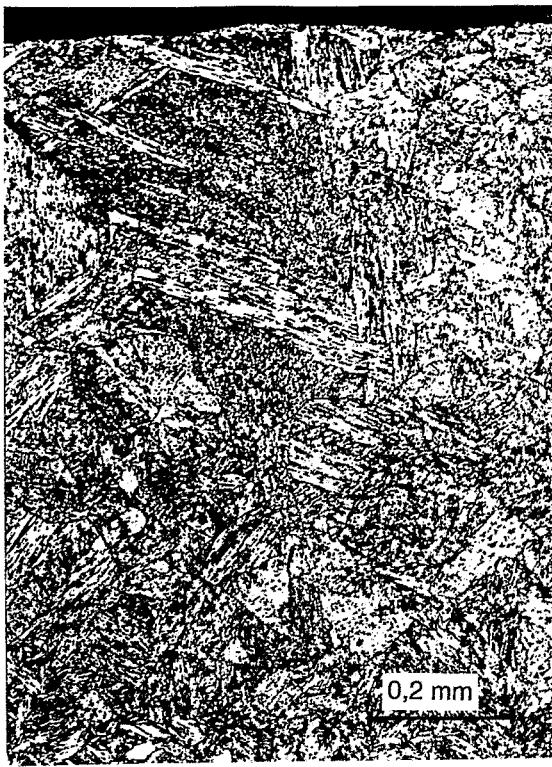
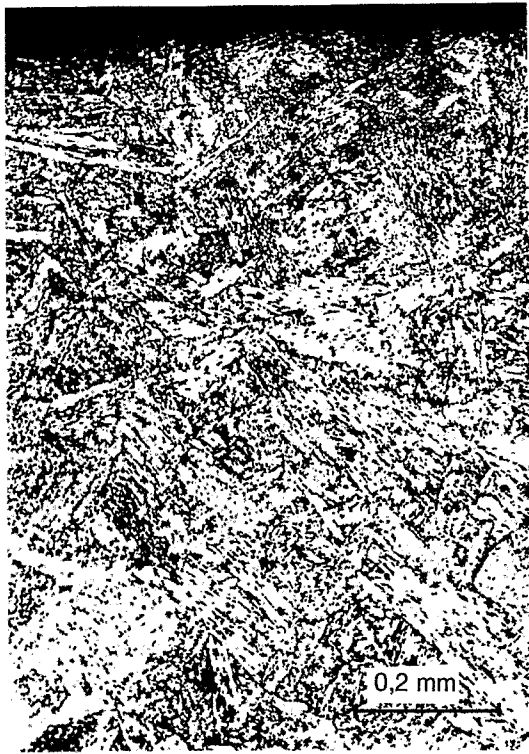
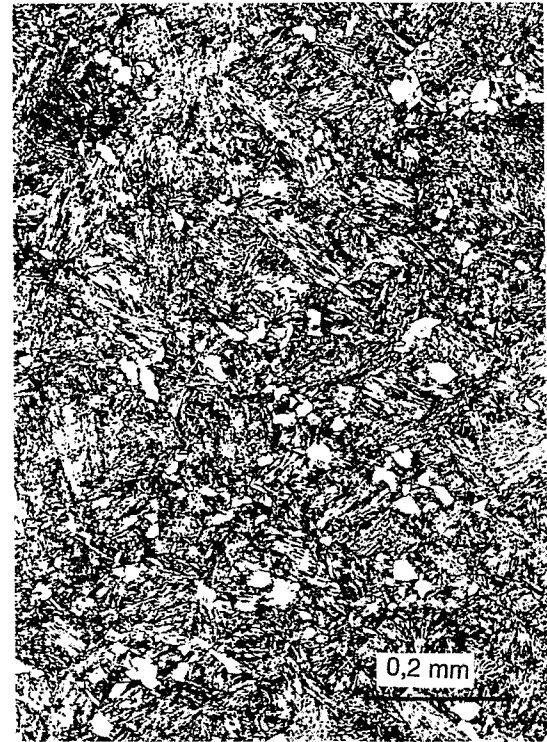
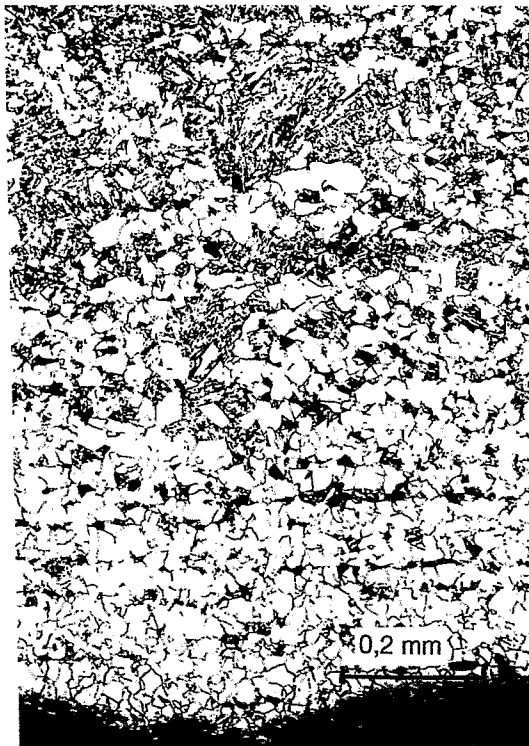
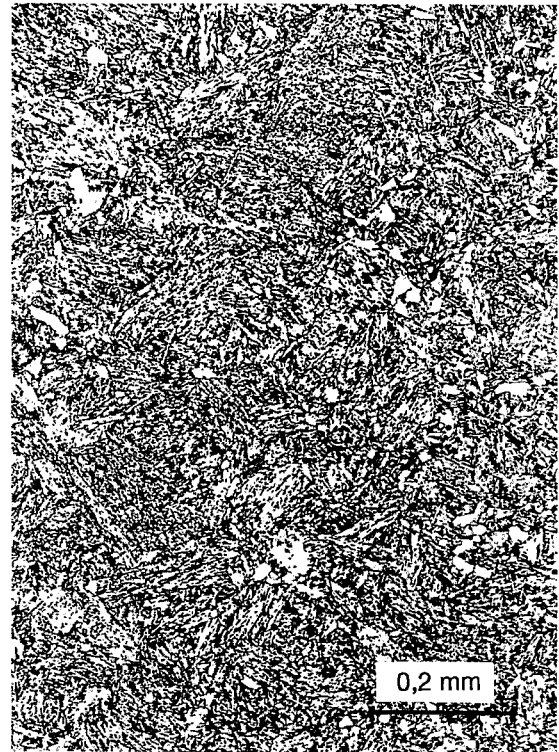
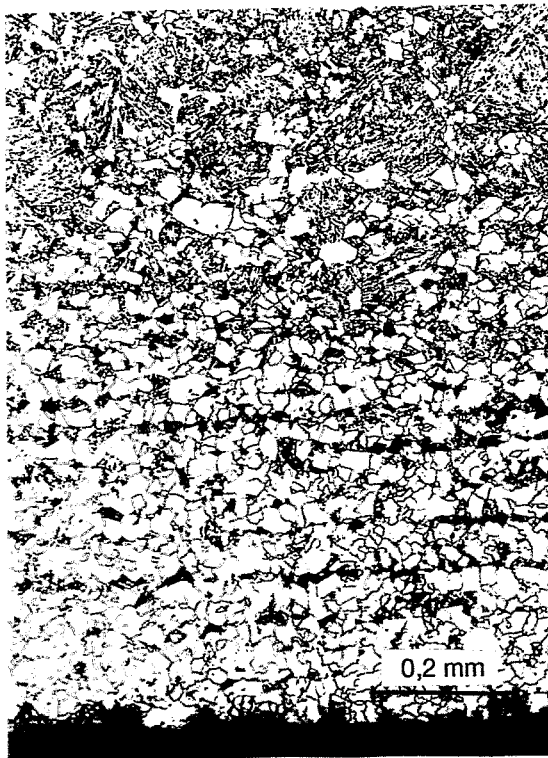
Optical micrographs of the cross section of the inside, the middle, and the outside of the vessel wall are shown for the different height positions in Figs. 23-27. The lower part (positions C2/1, C2/2) exhibits a quite homogeneous, fine bainitic microstructure containing a fraction of pre-eutectoid ferrite. Above all in the central part of the wall, there are so-called ghost lines, perceptible by the darker colouring in the micrographs. The ghost lines are produced by segregation of carbon and other alloy elements such as Mn and Mo.

Clearly different microstructure appears in the upper part of the vessel head. At the height position C2/3 the microstructure is a mixture of banded ferrite and perlite including isolated cluster of fine bainite or blocky ferrite. The nearer the location to the outside of wall the finer are the grains. Furthermore, at the outside a narrow surface layer of ferrite is formed. For the upper height positions, the content of perlite is reduced and the fraction of bainite is increased. At the inside a coarse lath-type of ferrite is formed (Figs. 25-27). The effect is particularly significant near the welding fusion line where this coarse bainite covers almost the total thickness. The residual wall thickness is covered by bands of ferrite in a bainitic matrix up to a narrow surface layer at the inside where polygonal ferrite is predominantly formed.

Another modification of the microstructure is observed from the height position C2/4 up to the weld. At the wall inside a zone (E according to Fig. 33) of very coarse bainite was generated and its extent amounts to 1 mm at positions C2/4 and up to 2 mm at C2/6 (Figs. 25-27). The formation of this zone requires two conditions: a) a relatively fast cooling rate and b) a temperature considerably above A_{C3} . The highest temperature during FOREVER-C2 was here and reached approx. 1100°C. The following region into the wall thickness (zone D) at the positions C2/4 – C2/6 consists of a finer bainite and pre-eutectoid ferrite. The ferrite is arranged like clusters. The extension of the region reaches from 1-2 mm (C2/4, Fig. 25) up to 12 mm (C2/6, Fig. 27). Subsequently, it follows a region (zone C) of banded ferrite and bainite, which extends up to the wall outside. It is wide at position C2/4 (9 mm) and very narrow at position C2/5 or C2/6 (0,5 mm). For the microstructure of zone C and D the annealing experiments do not provide analogous results, but one can conclude that the temperature was higher than A_{C3} (870°C) and lower 1050°C.

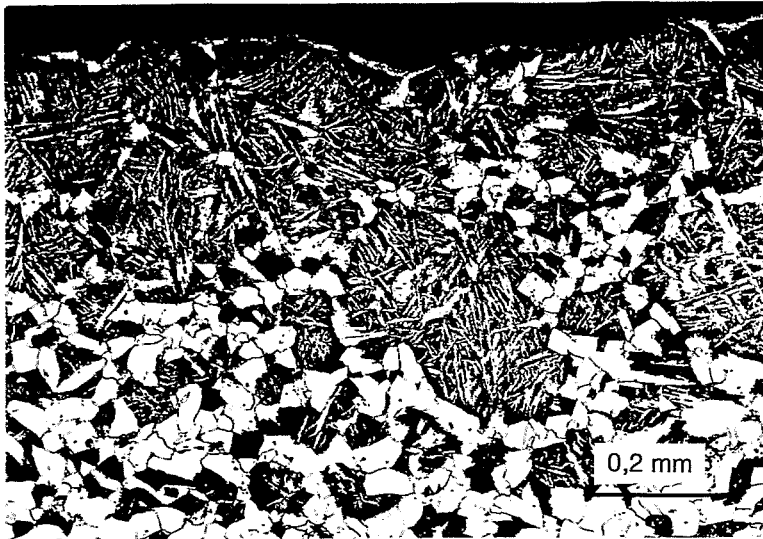
Fig. 30: Microstructure of sample C2/S, base metal of the cylindrical part of the vessel

The macrostructure of the 15 Mo 3 base metal of the cylindrical part of the vessel located near the weld is shown in Fig. 30. Predominantly, the microstructure consists in bands of coarse-grained ferrite and perlite. In this matrix, cluster of martensite-like structure are included. A narrow layer with martensite-like structure occurs at the inside. Near the outside the microstructure is a banded fine-grained ferrite-perlite mixture which is comparable with the microstructure of the C1/1 and C1/2 positions (Fig. 4) from the FOREVER-C1 experiment. Only at the outside, a ferritic layer without perlite is formed.

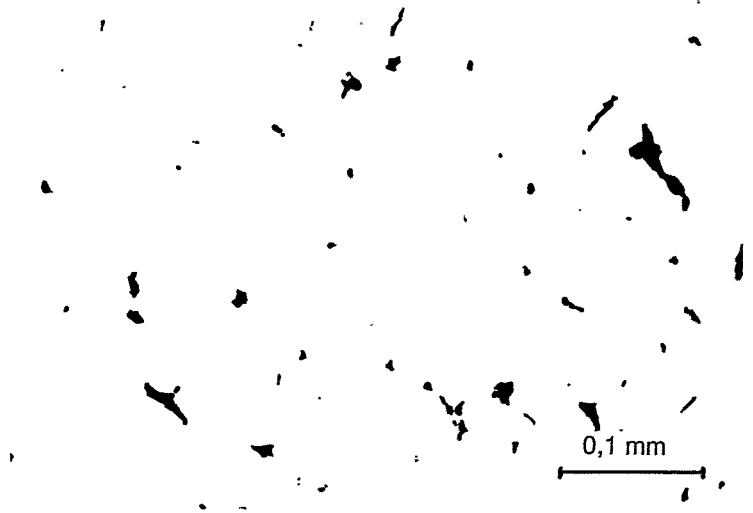
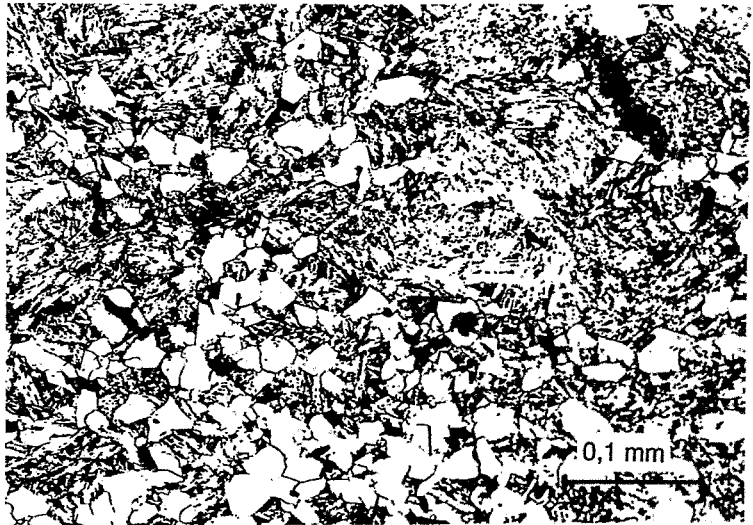
Fig. 31: Microstructure of samples C2/6 (top and middle) and C2/S (bottom), unetched (top and bottom) and etched (middle) cross section

The unetched cross section reveals the appearance of pores. They appear on the outside of wall at the height position C2/4 at first, cover the whole cross section at the positions C2/5 and C2/6 and disappear for positions above the weld. The concentration of pores decreases with increasing distance of the outside up to the middle of wall and increases again to the inside on a lower level. Fig. 31 shows examples of the pore structure for the outside of position C2/6 and the welding seam. On the outside of position C2/6 the largest and already crack-like formed pores can be found. In the weld the pores are more numerous but smaller and spherically shaped.

Numerous pores appear at the height positions C2/4 to C2/6, in the weld and in the cylindrical part near the weld. Shape, size and quality of pores change over the wall thickness and the height position of the vessel. The highest concentration are observed at the outside of the vessel close to the lower fusion line in the base metal. However, the size and shape of the pores differ for the base metal and the weld. The base metal possesses larger and crack-like cavitations, what indicates that at least the transition between secondary and tertiary creep stage was reached. The volume fraction of pores seems to correlate with the temperature related to the height position whereas the course over the thickness depends additionally of the mechanical loading conditions. Thus, the volume fraction is higher at the outside than the inside although the course of temperature is inverted.

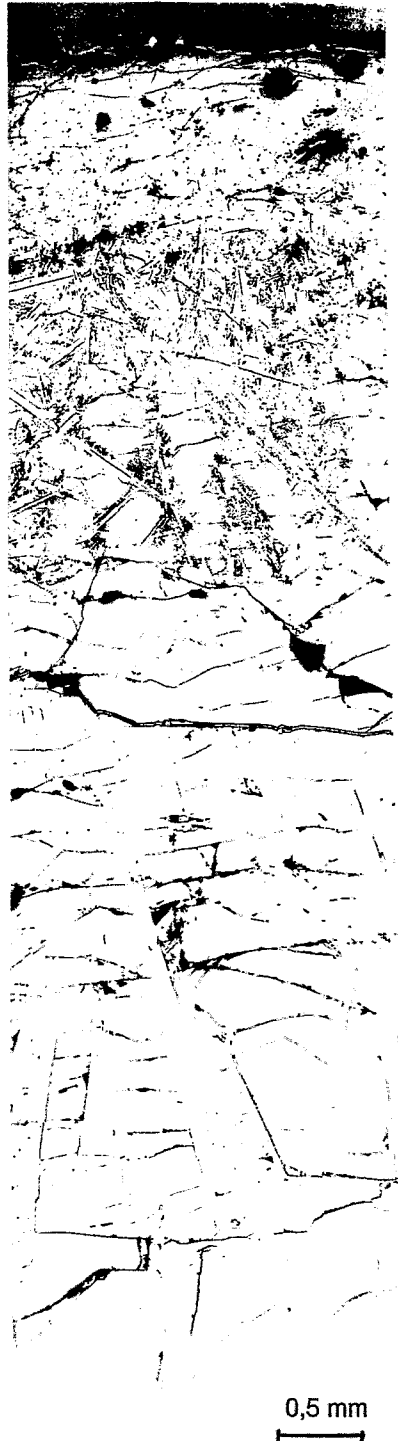
Fig. 47: Microstructure of the melt, FOREVER-C2

Fig. 47 shows the microstructure of the solidified melt. Their vitreous structure is characterized by the two phases CaO and B_2O_3 and numerous microcracks.

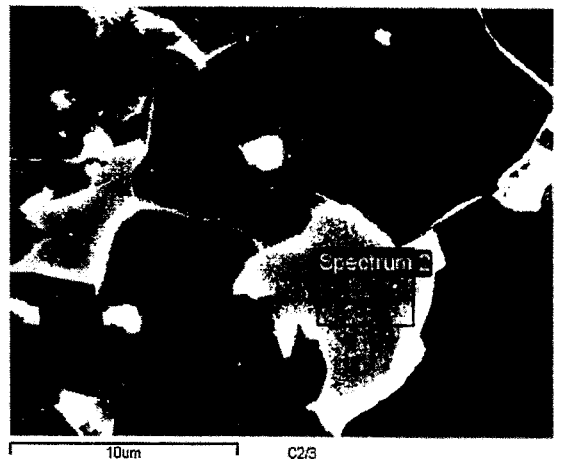
Fig. 48: Microstructure of sample C2/3, SEM photograph (top) and Energy Dispersive X-ray Analysis (bottom)

The etched sample C2/3 was tested by the scanning electron microscope to analyse components of the microstructure. It was measured by a scanning electron microscope ZEISS DSM 962 (25 kV) with backscattering detector and the microanalysis system INCA (Oxford Instruments) for Energy Dispersive X-ray analysis (EDX).
